Annual Community Report

West Melbourne Site July 2017 – Dec 2018.

HSEQ-RPT-2019-28

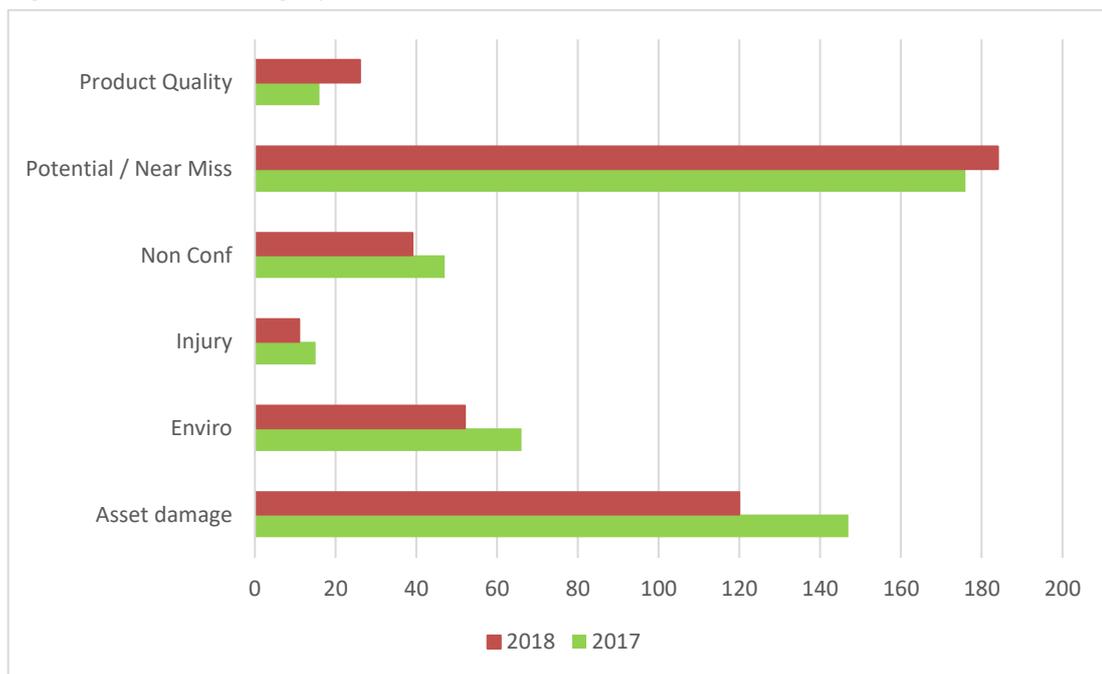
Figure 1 Incident Category Breakdown

There were 54 incidents raised during the reporting period which were broken down in the following categories:

An ongoing focus of incident reporting particularly on Potential / Near miss has seen an ongoing increase in the reporting of this category. This has resulted in an increase in actions being allocated through Integrum, and therefore more hazards being controlled and a safer workplace. The business will continue this focus as the standards of HSE continually improve within the organisation.

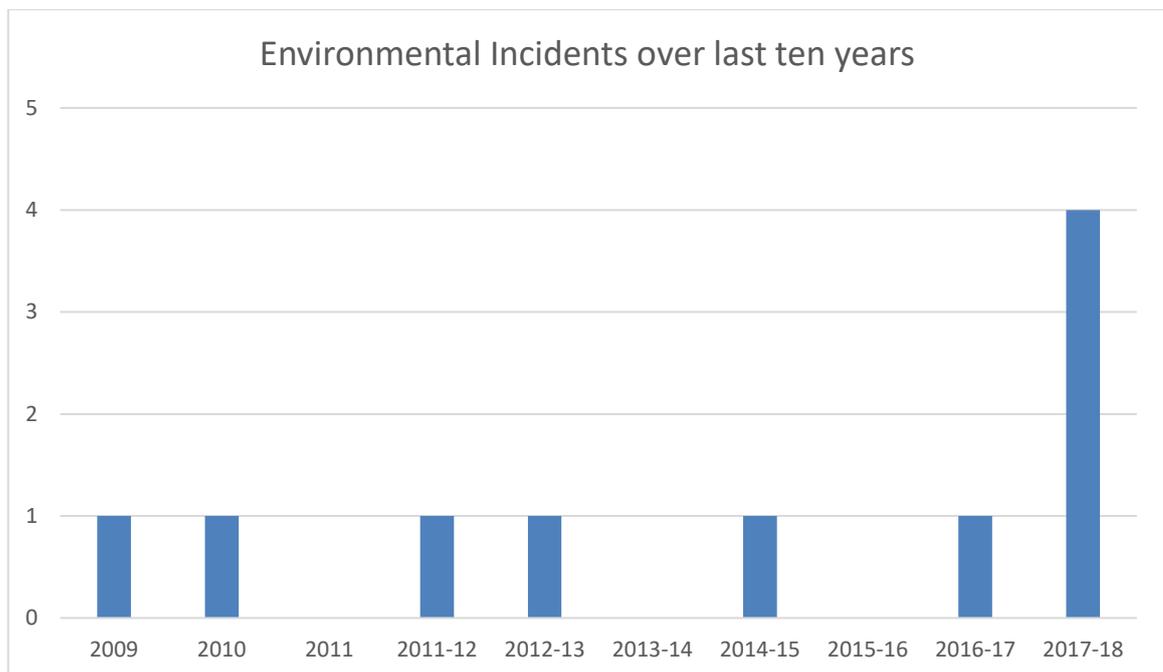
Figure 2 Environmental Incident History

Historical trend of environmental incidents is detailed below. These are defined as spills greater than 200 litres, EPA reportable incidents (i.e. cause or likely to cause an offsite discharge or odour), licence breaches and EPA infringement actions.

The 4 incidents this year relate to 3 loss of containment incidents and a failure to submit the annual return on time.

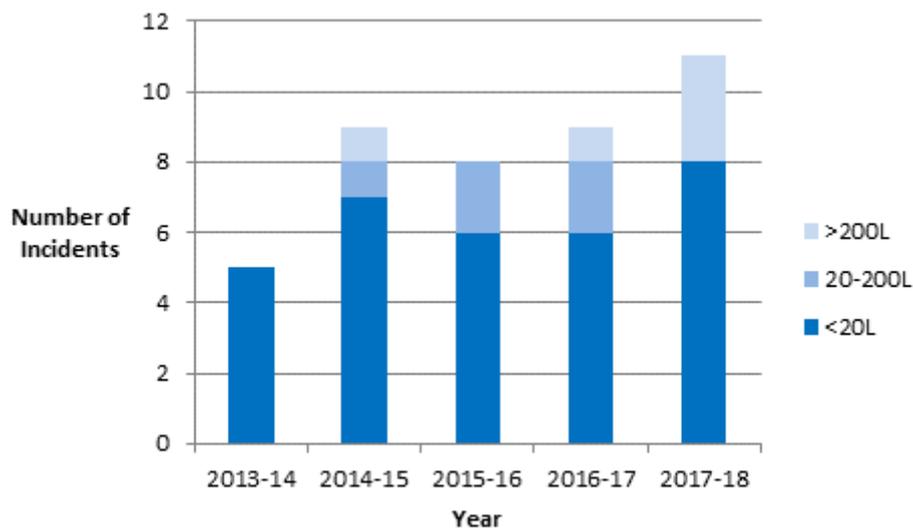
Figure 3 Loss of Containment – 5-year trend

The loss of containment trend for the site is shown below of the last 5 years.

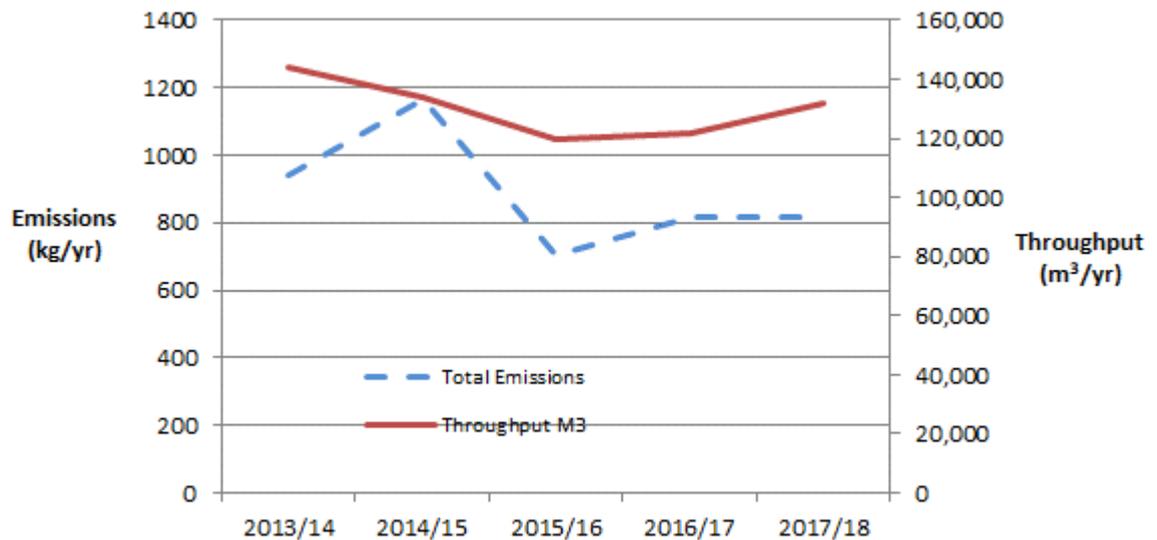
Figure 4 VOC Emission Trends

A five-year trend is provided in terms of total emissions and throughput is shown in Figure 4.

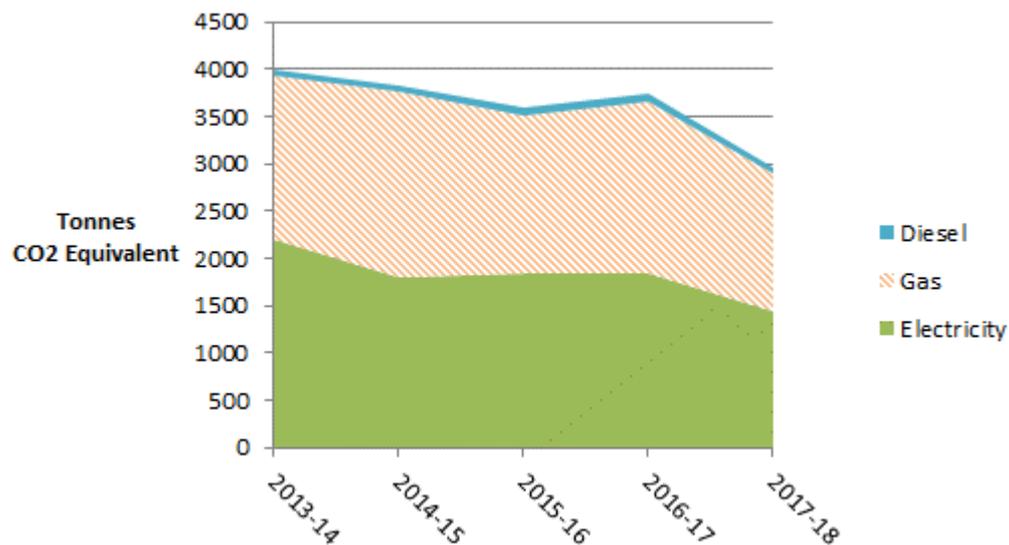
Figure 5 GHG Emissions (tonnes CO₂ Equivalent)

Greenhouse gas emissions are graphed below in equivalent tonnes of CO₂ emissions. These greenhouse gases are primarily associated with gas and electricity and diesel onsite. The trend over the last 5 years as well as the contribution of each of these sources is presented in Figure 5.

In the current year natural gas represented 46% of greenhouse emissions and electricity 51%.

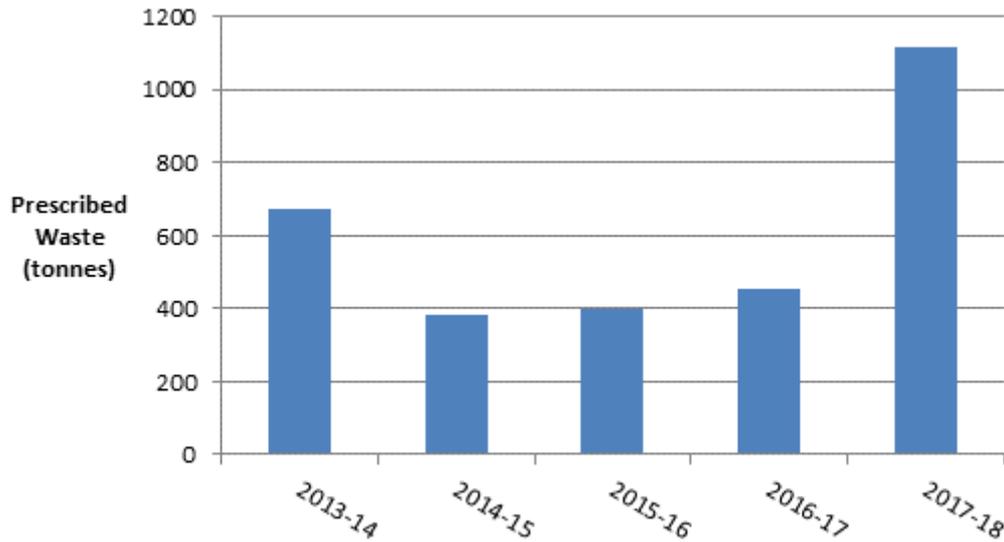
Figure 6 Prescribed Waste Generation

The level of waste depends on the throughput (no. of ships arriving), types of product being stored and the sequence in which ships arrive. The number of tanks that are cleaned as part of the Asset Integrity Program also impacts.

As can be seen from the trend in Figure 6 the level of waste generated in this reporting period has increased due to the LOC incident at Tank 49.
